**PANAMA CITY GENERATION III MINE ROLLER  
SYSTEM GOVERNMENT VERIFICATION TEST  
REPORT**

**REVISION A**

**NAVAL SURFACE WARFARE CENTER PANAMA CITY DIVISION**

**13 DECEMBER 2010**

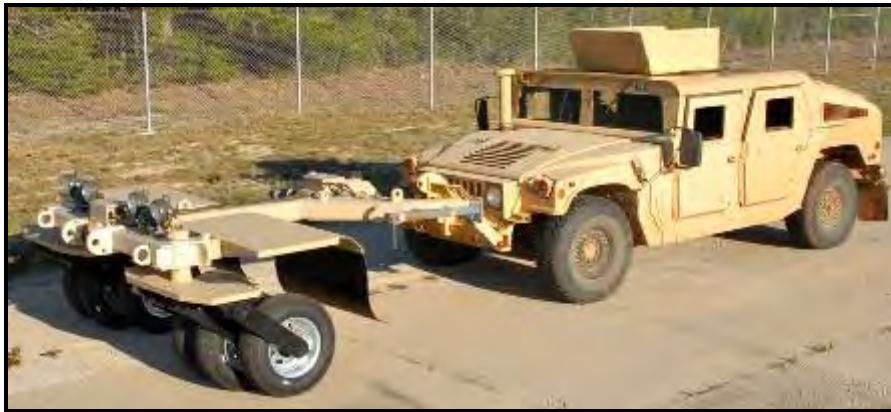
**Figure 1-6. PC GEN III MRS Scout**

The PC GEN III MRS Scout configuration (Figure 1-6) evaluated for GVT consisted of a shortened, lightweight Roller Frame carrying a Front Modular Table with two wheel banks, each containing four 26-in. diameter foam-filled wheels (Drawing 39125-1. The four wheels of each bank were arranged in the staggered CJ4 arrangement. The Scout configuration of the PC GEN III MRS is a lightweight variant, containing no hydraulic steering equipment, designed to be used with an armored HMMWV, providing the TV with track width coverage.

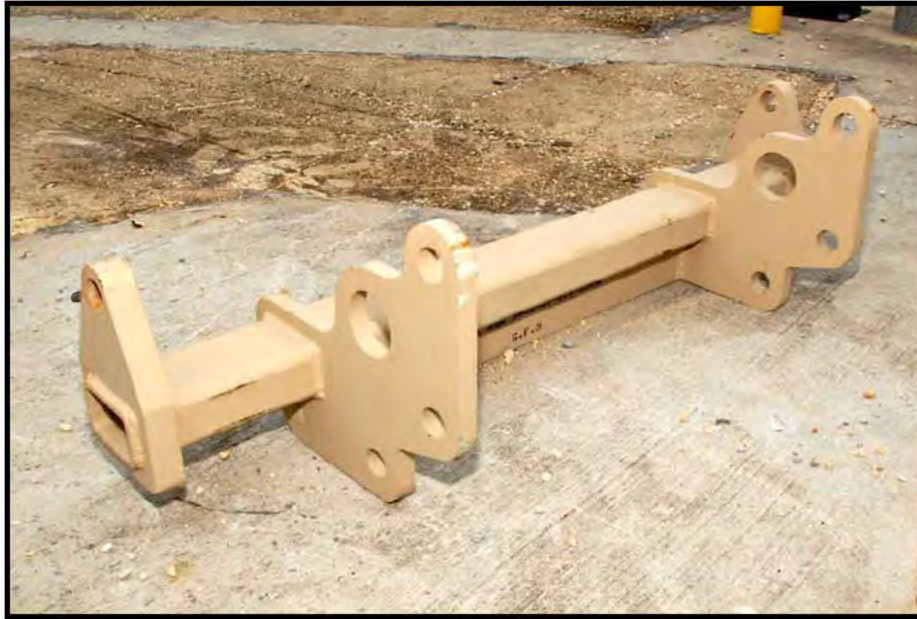
**Figure 1-7. MTVR FX MRIB**

The MTRV was equipped with an MTRV Field Expedient (FX) type (Figure 1-7) Mine Roller Interface Bracket (MRIB), which was used to attach the MRS to the vehicle.

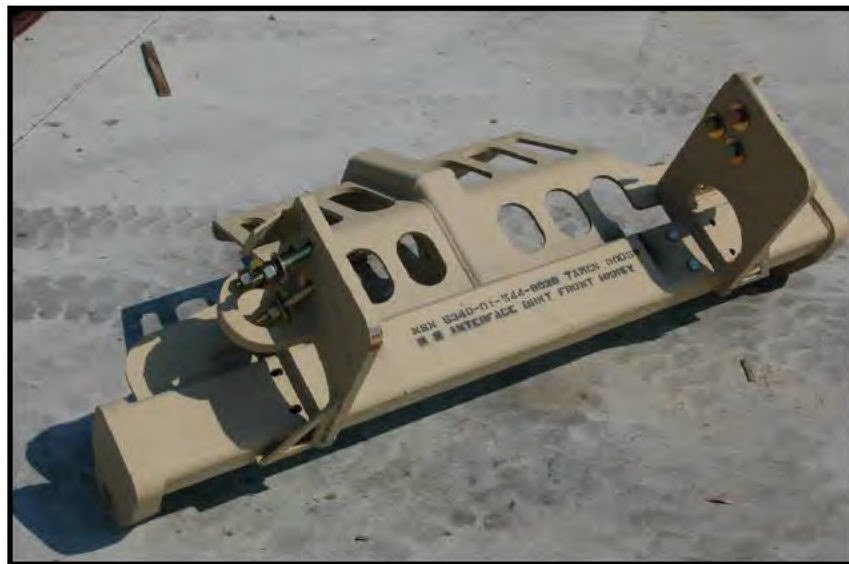
**Figure 1-8. HMMWV MRIB**

An HMMWV specific MRIB (Figure 1-8) was used to attach the MRS Scout to the vehicle.

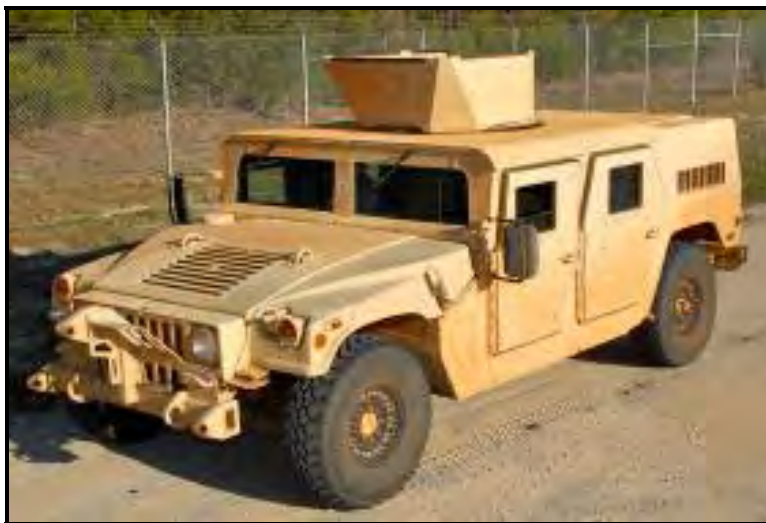
Figure 1-10. M1116 HMMWV

An armored M1116 HMMWV (Figure 1-10), featuring an expanded cargo area and an armored housing for a turret gunner, was used as the TV for GVT of the PC GEN III MRS Scout configuration. The HMMWV, fabricated by AM General, is a light, highly mobile, diesel-powered, four-wheel drive vehicle equipped with an automatic transmission.

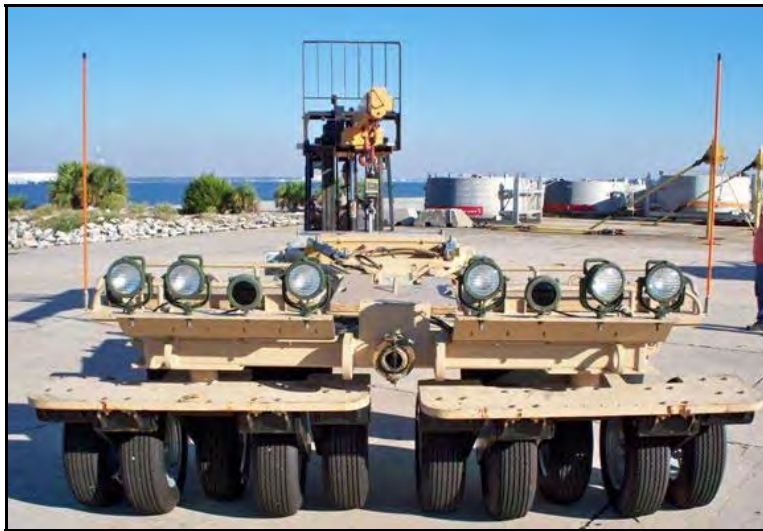
**Figure 2-1. Wheel Banks In Forward**

Note: Tongue weights are measured with the MRS wheel banks in the forward direction (i.e., when TV is in forward drive position, Figure 2-1), and in the reverse direction (i.e., when TV is in reverse drive position, Figure 2-2).

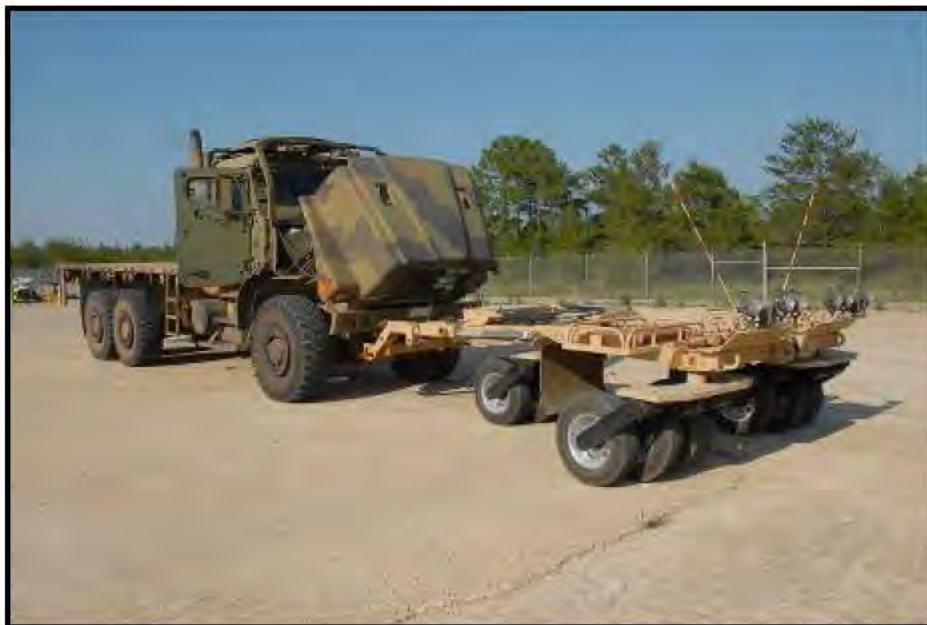
**Figure 3-1. Non-Interference Inspection (MRS 4x4 and MTVR)**

Results verifying non-interference of each MRS configuration with its host TV are recorded in Appendix B, Table B-2. None of the MRS configurations interfered with access to the hood, doors, or windows of their host vehicles (Figure 3-1).

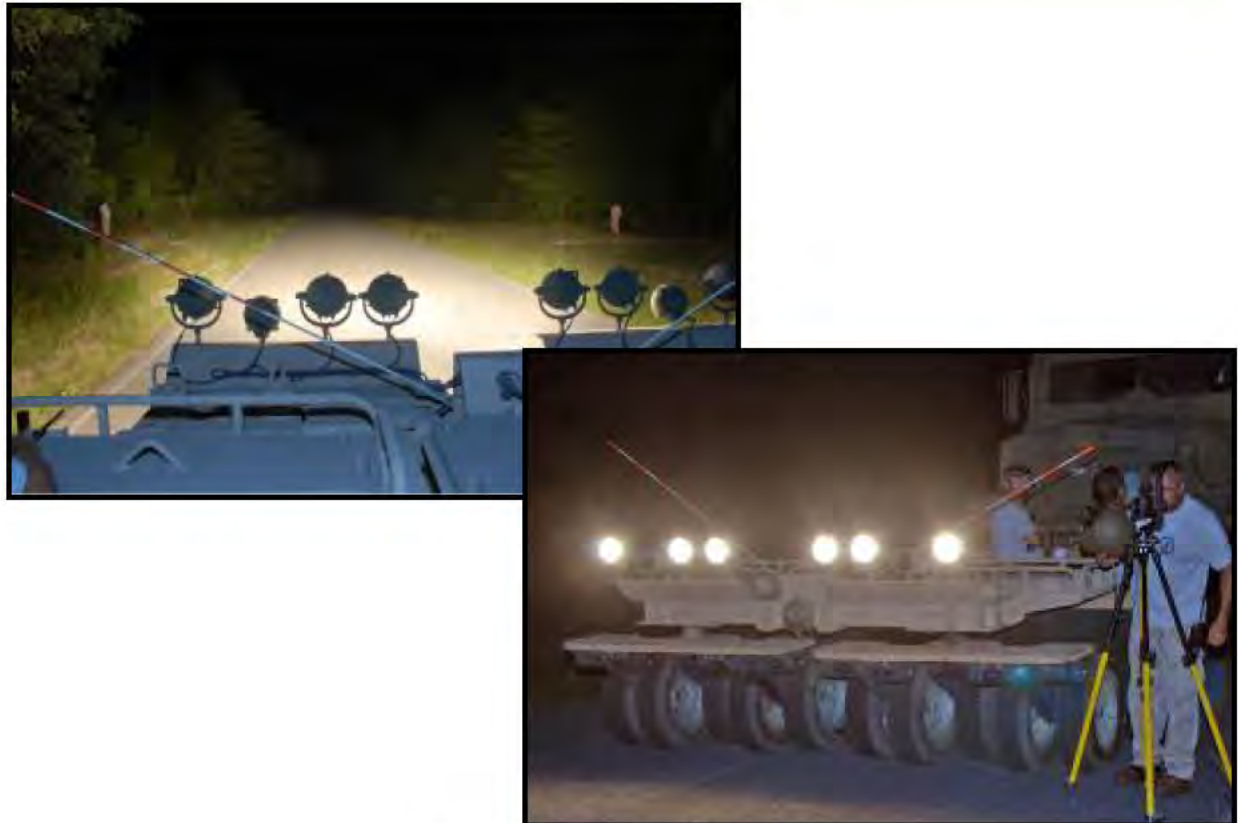
Figure 3-11. Driving Light Test

The MRS 5x5 and Scout configurations were evaluated during night time operations, and provided more than sufficient light to allow for safe operation (see Figure 3-11). Results of the driving light test are summarized in Table 3-4 below, and recorded in Appendix B, Table B-12.

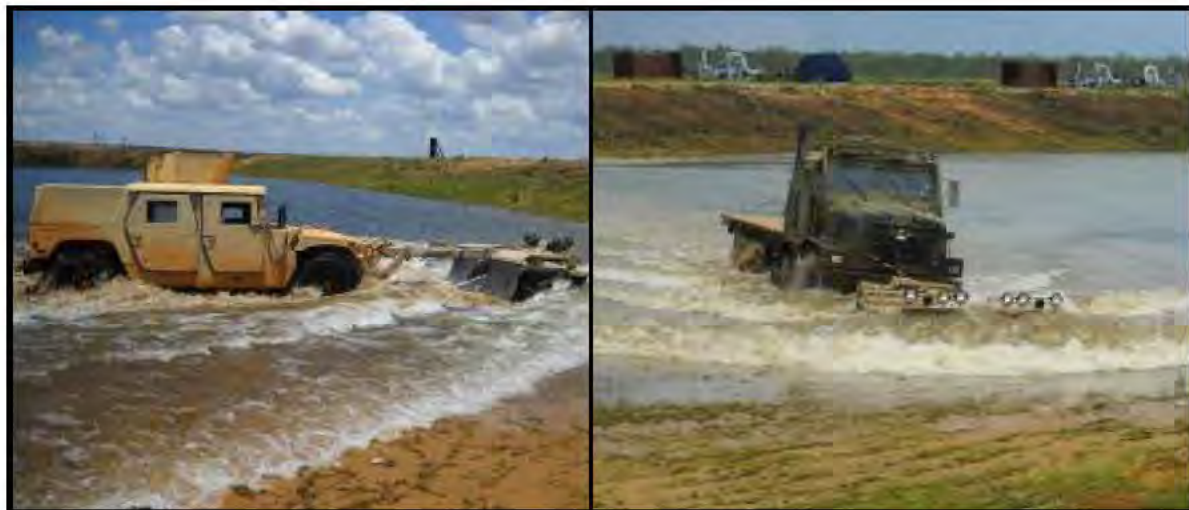
**Figure 3-12. MRS Fording**

Each MRS configuration successfully completed the fording test, making several passes (two to three) through a pond to a depth of 40–55 in. (see Figure 3-12). After the test, all hydraulic/electrical enclosures were examined for water intrusion, and lights and hydraulic systems were cycled to evaluate for proper function. Though some moisture was noted in the hydraulic box, there was no adverse affect to the system operation. Results for this test requirement for each MRS configuration are recorded in Appendix B, Table B-17.

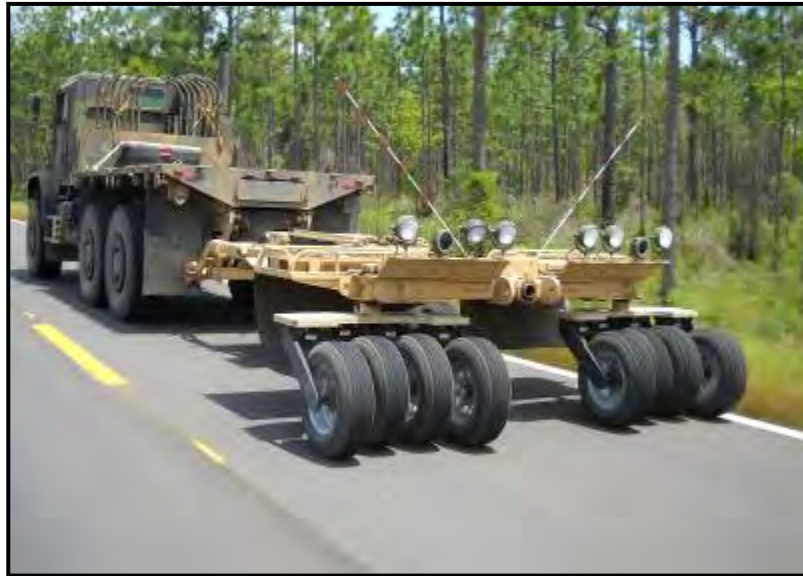
**Figure 3-13. Towing**

Each MRS configuration was easily attached to/detached from an MRS tow bracket mounted on the back of a MTRV and made ready to tow in less than 15 min. Each configuration was

easily towed over improved roads (Figure 3-13) for over 30 mi at speeds up to 45 mph. Results for this test requirement for each MRS configuration are recorded in Appendix B, Table B-30.

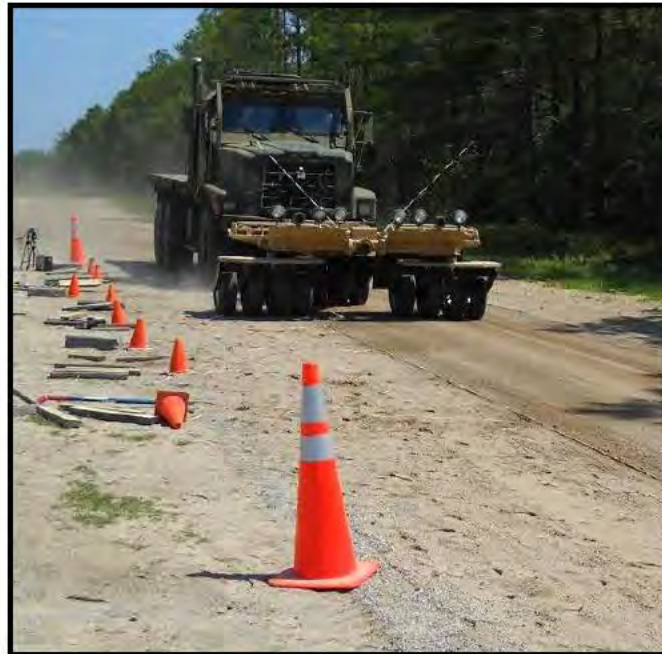
**Figure 3-15. Unimproved Road Test 2**

Tests were conducted at Eglin Range B-2, Auxiliary Field 4 during five different periods from 30 March 2010 to 10 September 2010. Testing was conducted on unimproved (Figure 3-15) and improved (Figure 3-16) road. Unimproved road tests were conducted using two different soil types (Test 1 and Test 2). Unimproved Road Test 1 was conducted in soil consisting primarily of red clay, but included dirt and rocks. Unimproved Road Test 2 was

conducted in soil consisting primarily of dirt and rock. Improved Road Test was conducted on an asphalt road approximately 20 years old.
